Bulletin 005/2013

Subject: Incorrectly Manufactured Hydraulic Hoses (80bar)
Affected Product: Cat6060/6060FS (RH340, RH340B)
Serial numbers: 340094 to 340125
Risks Identified: Defective hoses may result in serious injury or death.

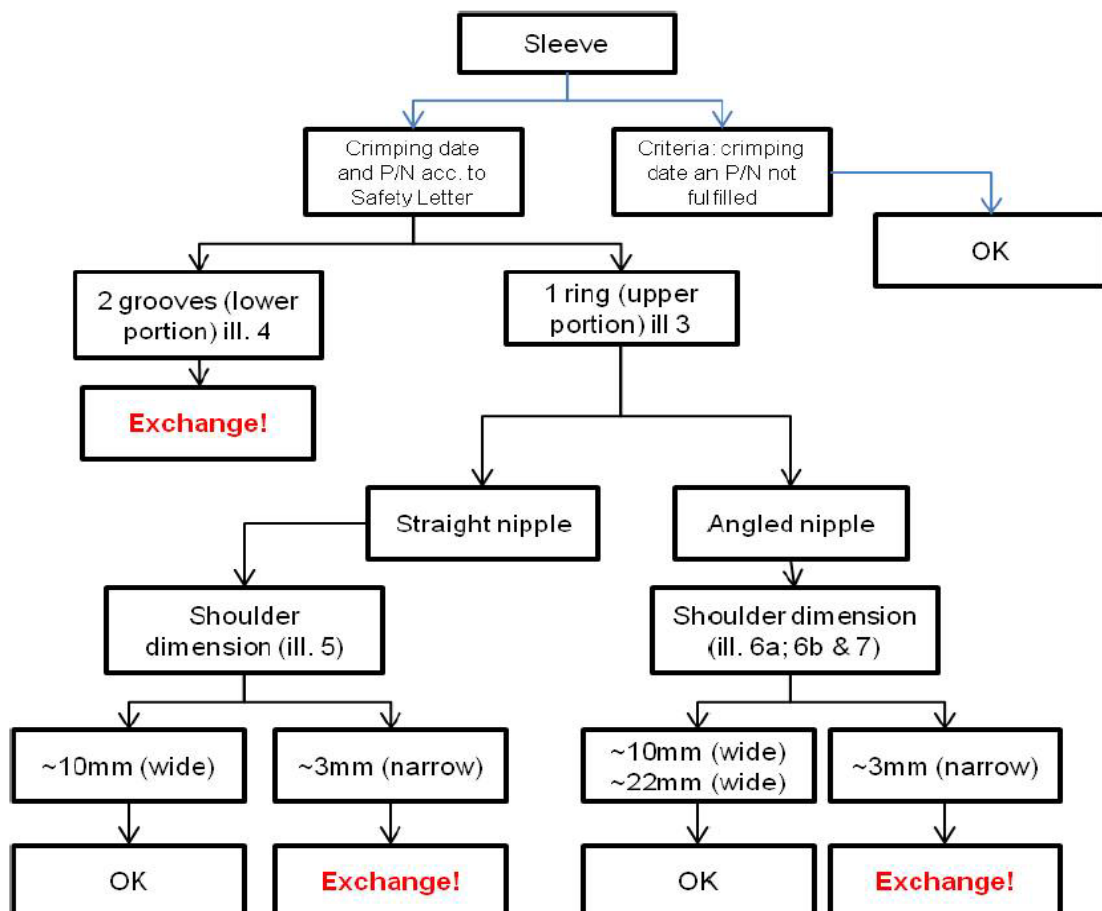
Flow Chart to identify good and bad crimping

Possible Combinations of nipples and sleeves		
	sleeve supplier 1	sleeve supplier 2
nipple supplier 1	good crimping	bad crimping
nipple supplier 2	bad crimping	bad crimping

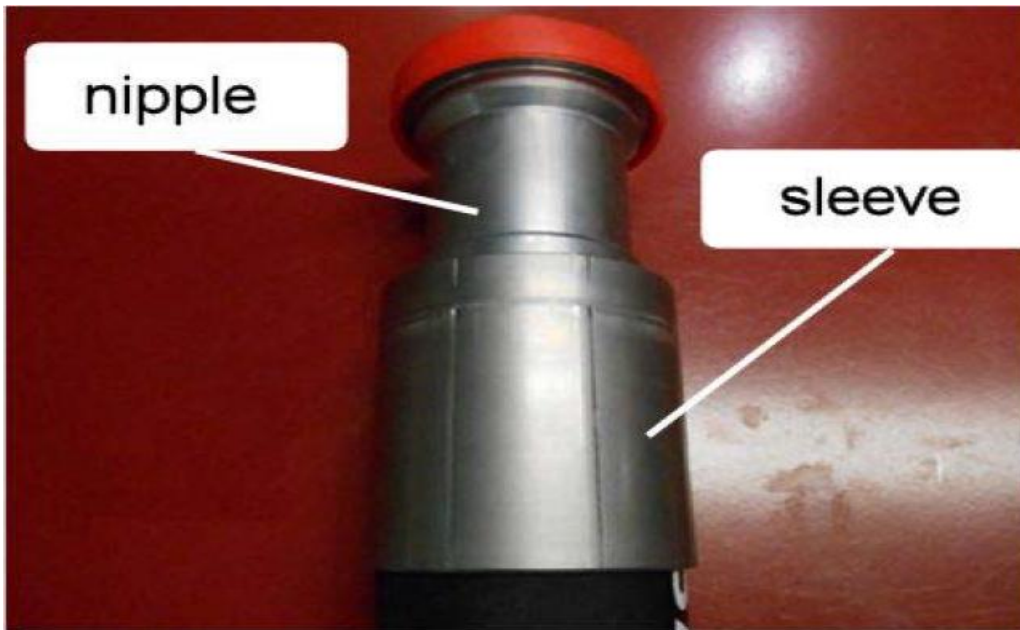
Illustration 1: layout of components
NB. Example shown is straight nipple; 45° and 90° nipples are similar construction

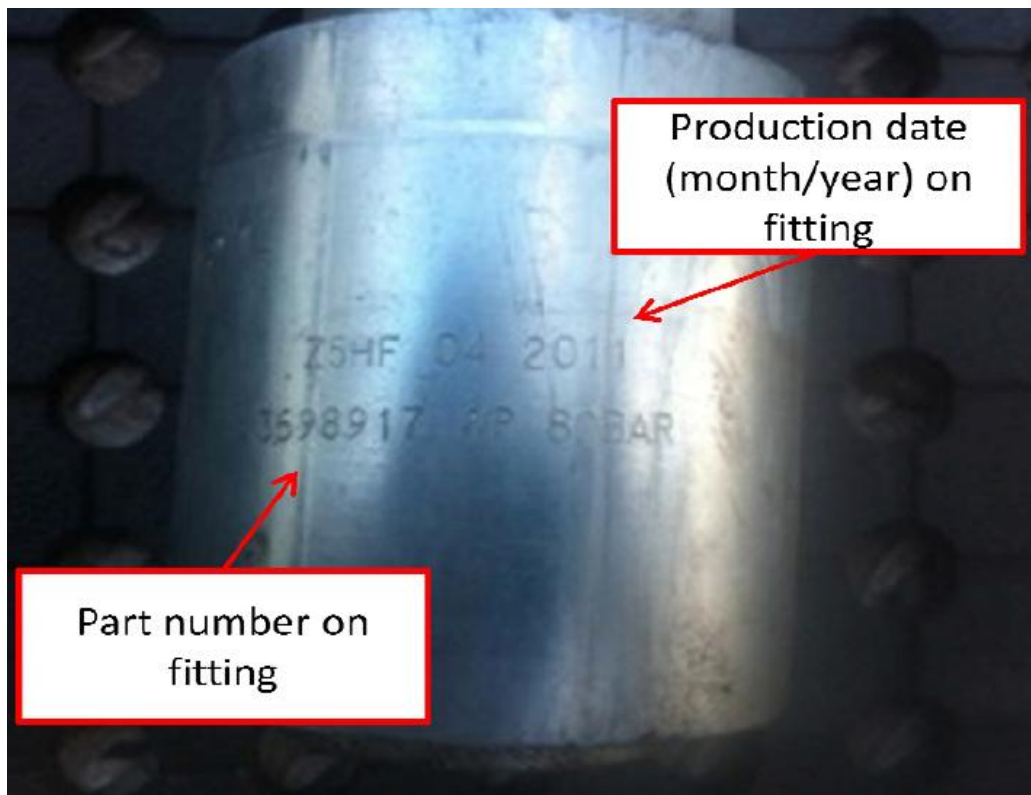
Illustration 2: Part-Number and production date (month/year) on hose fitting.

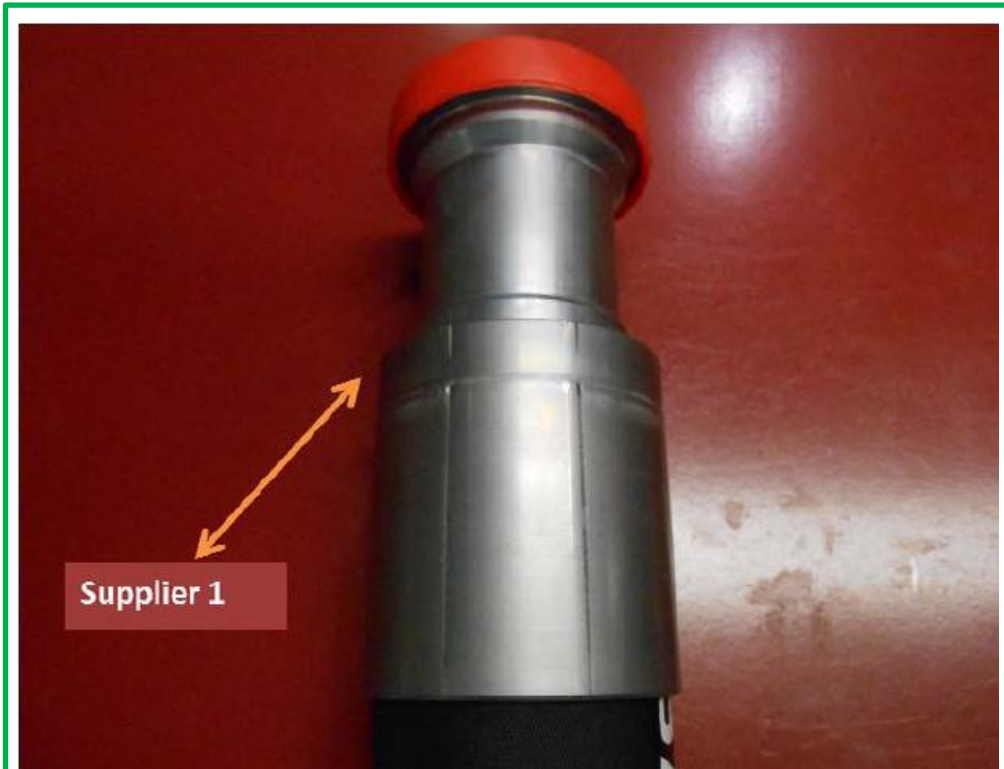
Illustration 3: Standard sleeve (**Good**)

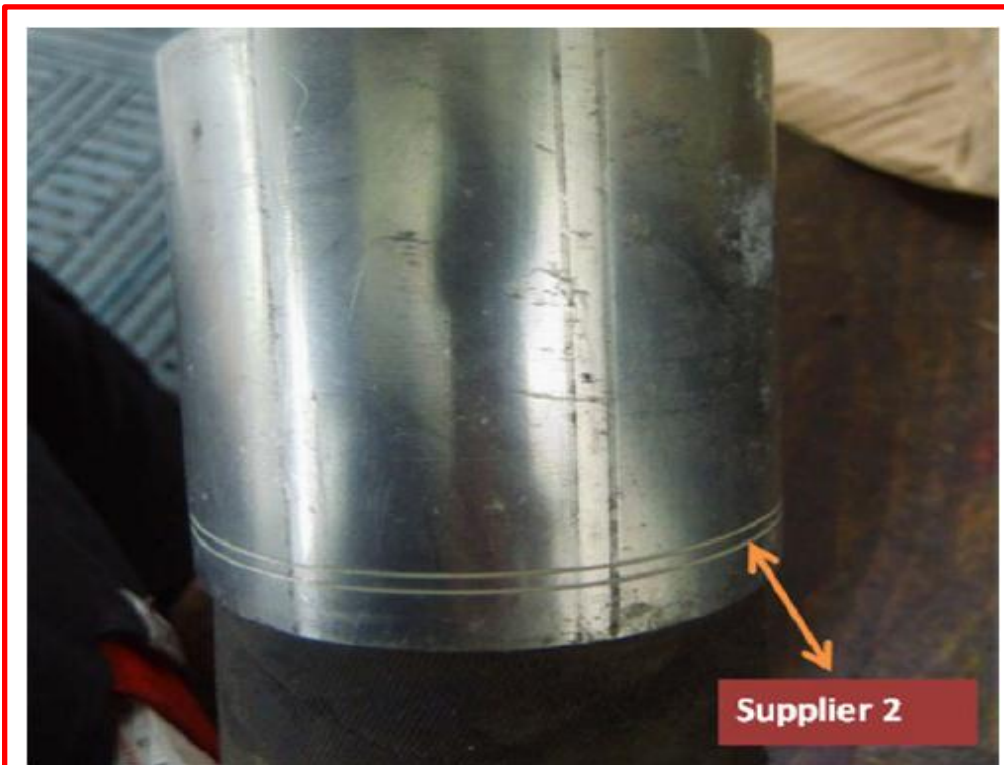
1. The part number and manufacturing date of the hose are stamped on the crimped sleeve - refer illustrations 1 & 2. The date stamped on the sleeve must fall in the range October 1 2010 to October 31 2011.
2. Affected hoses contain either a sleeve or nipple from supplier 2. Supplier 2 fittings can be identified by two rings on the sleeve circumference, as shown in illustrations 4 and 7 of this bulletin.

Illustration 4: **Supplier 2** sleeve always with two machined rings on circumference. (**Bad**)

1. Inspect machines in the affected serial number range. If the inspection shows defective hoses are fitted, replacement hoses must be ordered and fitted immediately.
2. Inspect parts stock holdings of affected part numbers shown in this bulletin. Defective hoses identified in this inspection must be replaced.
3. Destroy defective hoses by cutting the hose at the crimped fittings at each end to render the hose unusable and attach a picture of destroyed hose to the warranty claim.
