General Equipment Safety Bulletin

Bulletin 006/2013

Subject: Failure of Articulation Locking Pin-part no. 346-2547

Affected Product: Caterpillar Load Haul Dump machines R2900G & R1700G

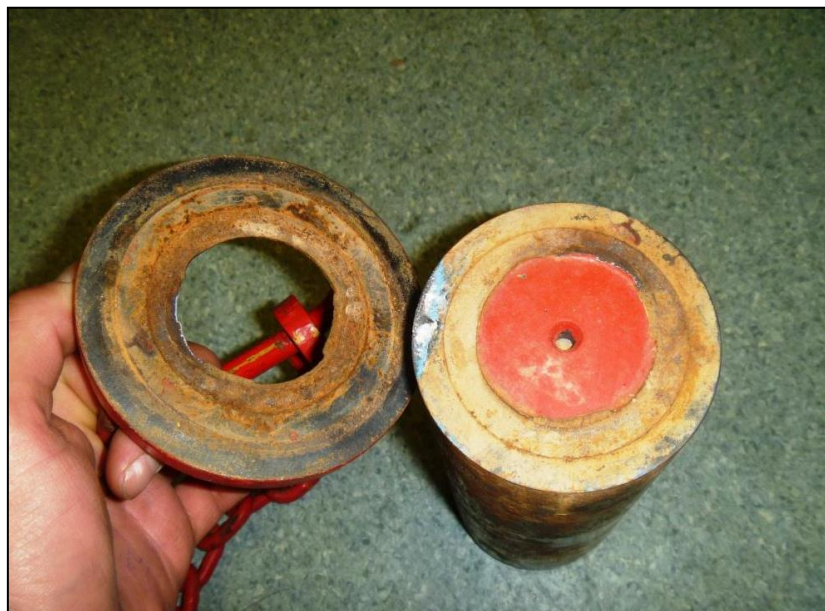
The report described the welded ring breaking away from the 346-2547 pin assembly, as shown in Figure 1 below.

Figure 1 – showing lock pin failure mode

If the welded ring breaks away from the 346-2547 PIN AS, there is a potential for the 10 kg pin to fall unexpectedly while being handled, or after installation, causing personal injury and or property damage.

1. For affected product, inspect the welds on the pin shoulder for quality and signs of cracking, if any visible cracking is found, replace the pin with a new 346-2547 pin assembly. Ensure that the replacement pin is the updated part as shown in Figure 2 above before installation.
2. Visually inspect the pin collar area for defects prior to each use. Do not use a defective pin; replace the pin with an updated or serviceable pin of the same part number.

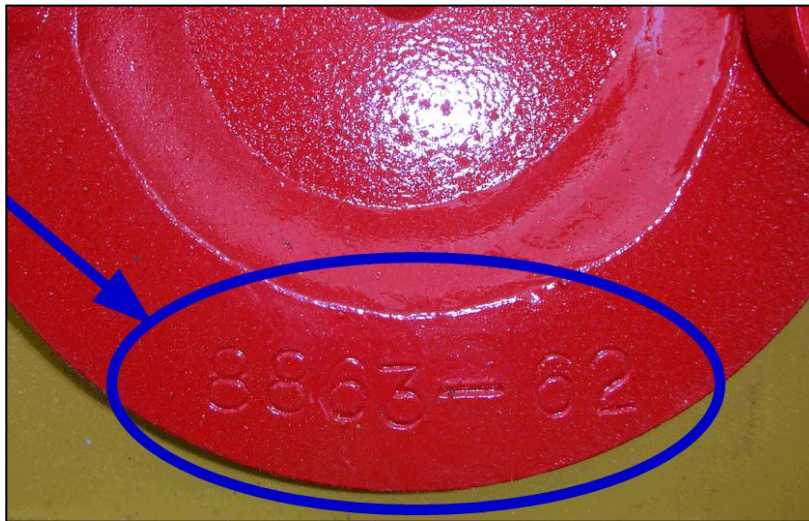
Figure 2 Updated lock pin

An updated 346-2547 pin is now available that has a revised welding process. To distinguish the updated pin from the earlier pin, the updated part is stamped with a 2-digit pin number and a 4-digit batch number for traceability. These numbers are located on top of the pin [as shown in figure 2 above]. The earlier version of the 346-2547 pin **does not** have the 2-digit pin number and 4-digit batch number.
