Bulletin 013-01/2013 Revised March 17 2014

Subject: Failure of Front Wheel Spindles on Large Motor Graders.

Affected Product: 16G, 16H, 16M, 24H, 24M Motor Graders.

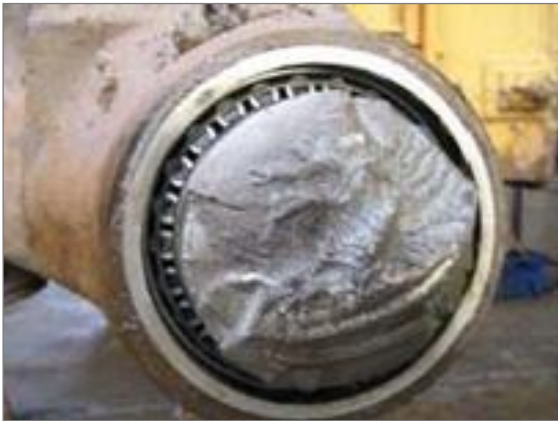
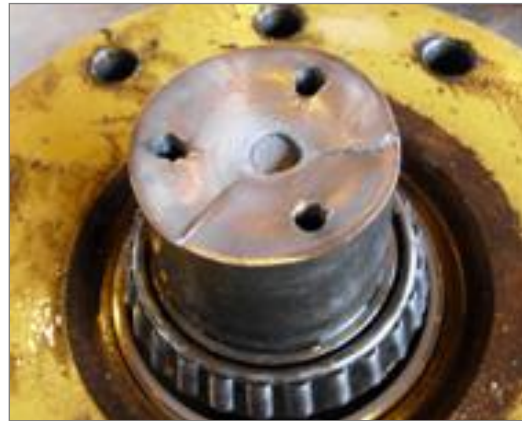
Fractures have occurred in front wheel spindles on large motor graders used in mining applications. The images below show the two types of failure mode that have been observed.

If a front wheel spindle fractures, the front wheel assembly may separate from the machine with the potential to cause personal injury, and/or property damage.

“The front wheel spindles will fail in certain applications due to impact or overload conditions. The anticipated design life of the front wheel spindles is 24,000 hours. Actual life achieved will vary according to outside influences such as site conditions, machine operation, machine application, and optional attachments fitted to the specific machines.”

Media number SEPD1533 announcing the availability of a more robust 383-1185 front wheel spindle for 24H and 24M motor graders. This new spindle became effective in production from serial number B9K654-UP, and is adaptable to 24H and 24M machines, serial numbers 7KK1-UP and B9K1-653.

Media number SEPD1701 announcing the availability of a more robust 437-8983 front wheel spindle for 16G, H & M series motor graders. This new spindle became effective in production from serial number R9H893-UP. It is adaptable to the following 16G, 16H and 16M machines: 93U1-UP, 6ZJ1-UP, ATS1-UP, B9H1-UP and R9H1-892.

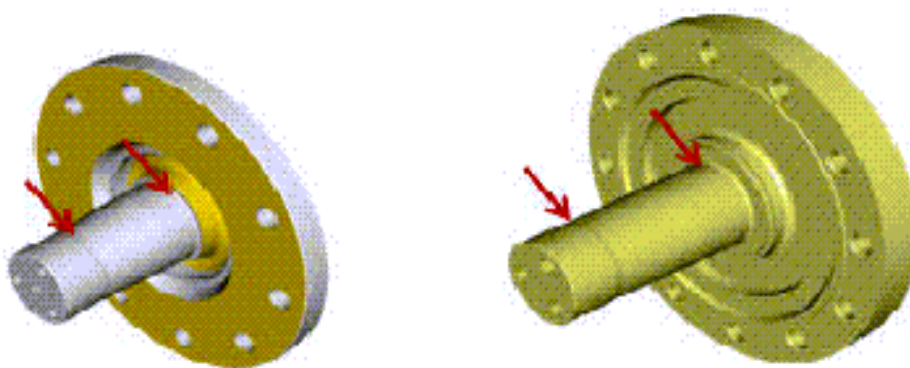
Front wheel spindle fractures have been occurring at the base of the spindle behind the outer tapered roller bearing, and also near the bottom of the tapped holes in the spindle retaining bolt hole area. These locations are identified in the illustration below.

16G/H/M spindle

24H/M spindle

To reduce the risk of an unexpected spindle failure, this bulletin outlines recommendations for additional inspections of the spindle, and replacement of the spindle after 24,000 hours service. It is recommended that the outcome of all spindle inspections be recorded in the machine's maintenance log.

At 12,000 part hours or first life overhaul, remove and inspect the front wheel spindles. Perform a visual inspection and a magnetic particle examination of the spindle. Also, perform ultrasonic testing in the area around the retaining boltholes. Do not reuse spindles that have crack indications at any location.

At 24,000 part hours or second life overhaul, replace the spindles with the latest part available.

Perform the above NDT inspections immediately, and at 6,000 hour intervals thereafter, if any of the following occur:

1. **The machine is involved in an incident** where the spindle has been subjected to impact forces significantly greater than those encountered in normal operation.
2. **There is impact damage evident** on the following components: the front axle assembly e.g. arm assembly, spindle housing, lower spindle housing pivot pin (kingpin) retainer bolt and washer.

If a crack is detected during any inspection, discard the front wheel spindle and replace with new, using the latest part available. Replace any other damaged parts. If no cracks are detected, mark the front wheel spindle as an acceptable reusable part with an air engraver or steel stamp set. Mark all front wheel spindles on the inboard face of the rim flange as per the illustration on page 3.

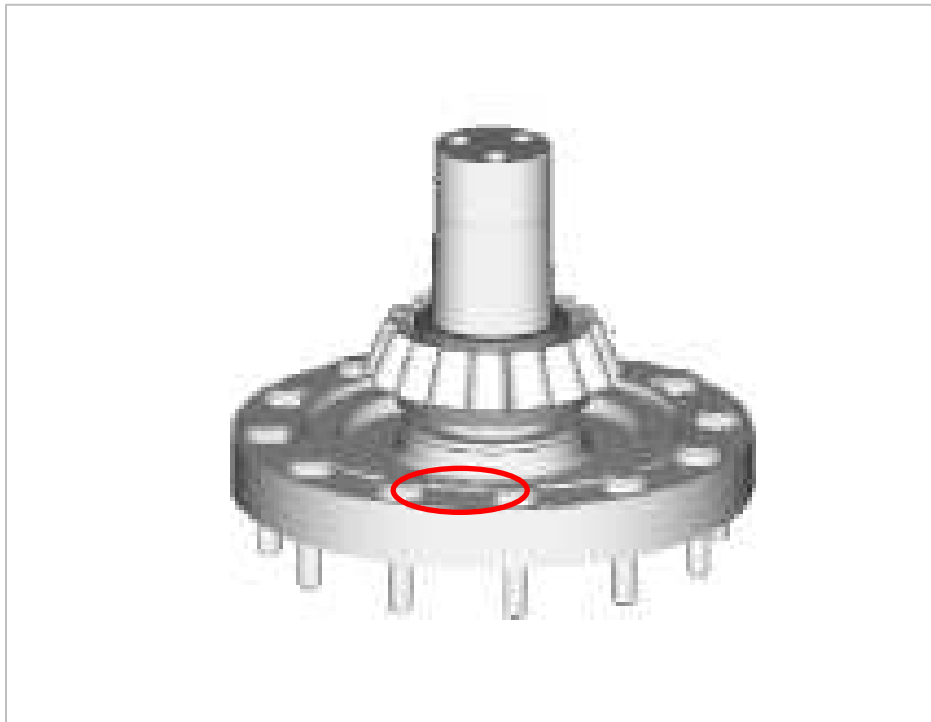
If "1 - 12" was marked on a front wheel spindle, the "1" would indicate the first inspection, and the "12" would indicate that there were 12,000 hours on the part at the time of inspection.
