## Bulletin 014/2013

**Subject:** Wheel Loader/Wheel Dozer Access Systems installed by Hastings Deering.

# General Equipment Safety Bulletin

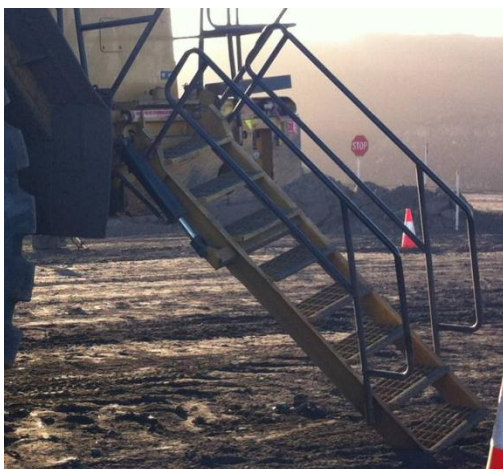
Figure 1

One of the pivot points on a wheel loader access system failed. Figures 1 and 2 below show a general view of failed stairs and a close up of the problem area.

Investigation has determined that there was insufficient clamping force on the inner race of the pivot bearing. This allowed the loads encountered during normal operation to be borne by an area of the pivot that was not intended to carry these loads.

- Immediately conduct a visual inspection in the area of the access system pivot point, for cracking around the stairway pivot point flanges.
- If no cracks are found perform the Permanent Corrective action listed below at the next scheduled maintenance interval. Continue to conduct visual inspections at 250 hour intervals, until the Permanent Corrective action has been performed.
- If cracks are found, immediately tag-out the stairway in accordance with site procedures and contact your Mining Support Representative for the re-work procedure required to repair the stairway pivot joint. The permanent corrective action below will form part of the repair instructions.

1. Order four shims Hastings Deering part number A244601.
2. Insert one shim between the stair flange inner surface and the bearing outer surface on both sides of the pivot point mount and for both pivot points (refer figure 3 on following page)
3. Re-torque bolted joint to 120Nm  $\pm$ 20Nm
