Bulletin 015/2013

Subject: Off-Highway Truck, Motor Grader & Excavator Access Systems installed by Hastings Deering.

Failure of the access system stair pivot point.

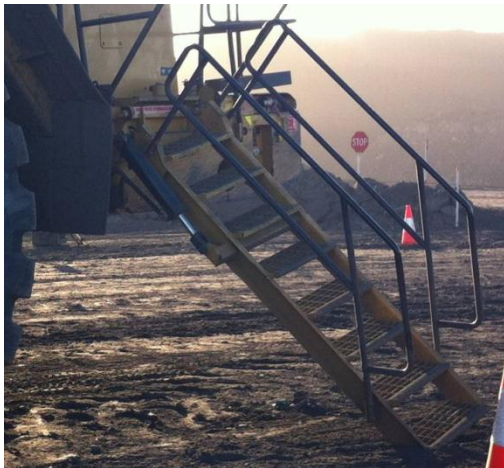
Figure 1

One of the pivot points on a wheel loader access system failed. Figures 1 and 2 on page 2 show a general view of failed stairs and a close up of the problem area. Investigation has determined that there was insufficient clamping force on the inner race of the pivot bearing. This allowed the loads encountered during normal operation to be borne by an area of the pivot that was not intended to carry these loads.

- Immediately conduct a visual inspection in the area of the access system pivot point, for cracking around the stairway pivot point flanges.
- If no cracks are found, perform the Permanent Corrective action listed below at the next scheduled maintenance interval. Continue to conduct visual inspections at 250 hour intervals, until the Permanent Corrective action has been performed.
- If cracks are found, immediately tag-out the stairway in accordance with site procedures and contact your Mining Support Representative for the re-work procedure required to repair the stairway pivot joint. The permanent corrective action below will form part of the repair instructions.

1. Order four hardened shims, Hastings Deering part number A244601 and two shims, Hastings Deering part number A107607-01.
2. There are two pivot points where the stairs are attached to the machine. One will have smaller gaps between stairway stringers and the bearing mounted in the frame mounting lugs. Support the stairs and remove the mounting bolt on the pivot point with the smaller gaps, and insert one A244601 hardened shim (0.8mm thick) between the stair stringer inner surface and the bearing outer surface on both sides of the pivot point mount (refer figure 3). Reinstall the mounting bolt and nut.
