## Bulletin 017/2013

**Subject:** Solenoid valves that are not in use, or in storage may be internally corroded and need to be tested.

# General Equipment Safety Bulletin

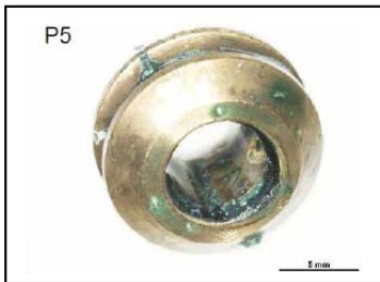
Corrosion deposits in the valve can lead to increased frictional resistance to movement of the internal parts which could cause malfunction of the solenoid valve if the valve was installed. Malfunction of the solenoid valve may result in unintended or uncontrolled movement of hydraulically-actuated roof support components.

Stored with CV50 DF

1. Inspect existing stocks of Longwall double solenoid valves in parts warehouses for applicability to this bulletin.
2. If valves in the affected product serial number and date range are found, return the parts to Hastings Deering for testing and/or replacement. Hastings Deering will provide an exchange valve. Valves found to be faulty will be returned by Hastings Deering to the manufacturer.

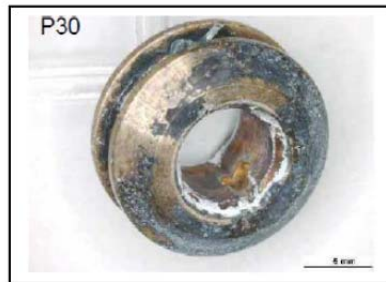
Stored with Solcenic 801E

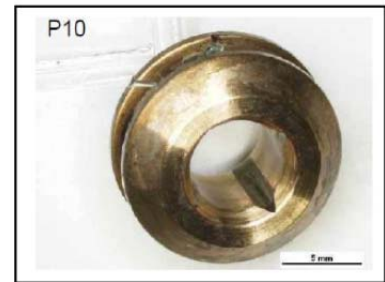
An improved corrosion protection fluid [Quaker Minetech Protection Fluid] has been implemented at the factory on valves with serial numbers after 0496 13 34 16966 and these valves are NOT affected.

Stored with Minetech Protecion Fluid
