## Bulletin 01/2015

**Subject:** Engine fuel system hoses - D10T and D11T Track Type Tractors

**Affected Product:** Current field population of D10T<sup>1</sup> and D11T<sup>1</sup>

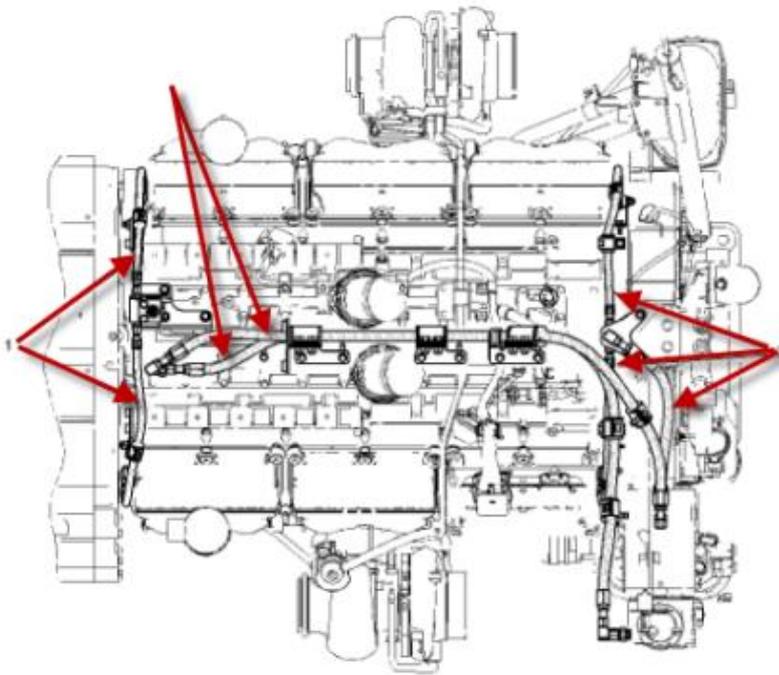
**Figure 1. Fuel Line Identification**

The flexible fuel lines fitted in the engine compartment of the affected product are subject to movement and abrasive wear before full engine life is achieved. Fuel leakage and fire may occur, due to improper assembly and routing, or deterioration of the rubber grommets securing the lines. Figure 1 shows the location of the affected lines.

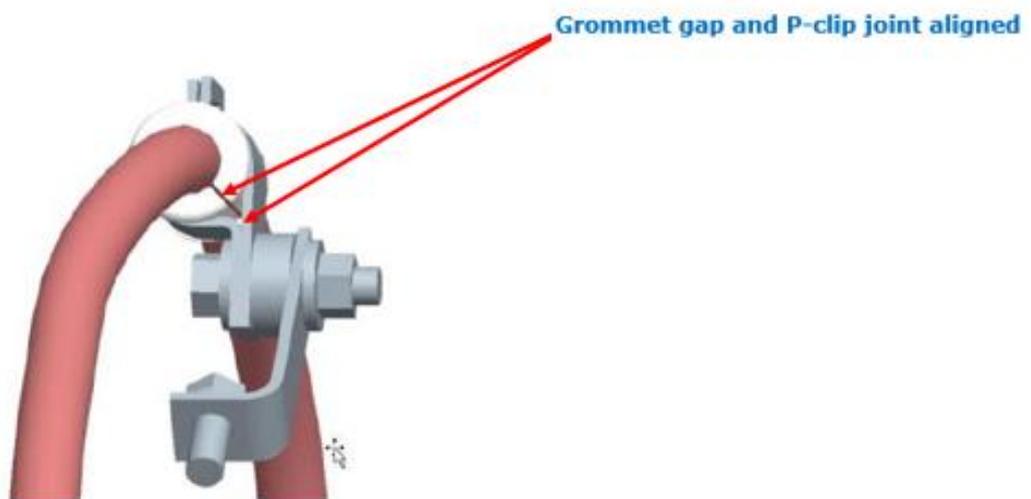
**Figure 2. Ensure correct alignment between grommet opening and P-clip joint**

- Look for signs of fluid leaks, hose chafing, contact marks, and rubbing that may indicate excessive hose movement or poor installation.
- All P-clips must have the rubber grommets fitted with the opening in each grommet aligned with the joint in the P-clip. Refer figure 2.
- The hose should not have clearance in the grommet – move the hose to check for clearance. Movement is usually the result of wear on the internal diameter of grommet and external surface of the hose. Refer figure 3. Replace worn, hardened or damaged hoses and grommets. **NB** Dirt and other contaminants can accelerate the wear process, and cause corrosion of fittings.
- Ensure the hose does not contact anything other than the rubber grommet in the P-clips.

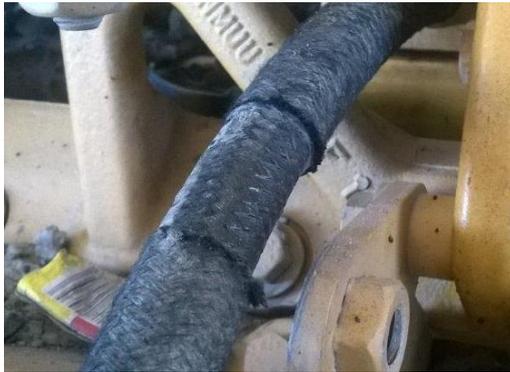
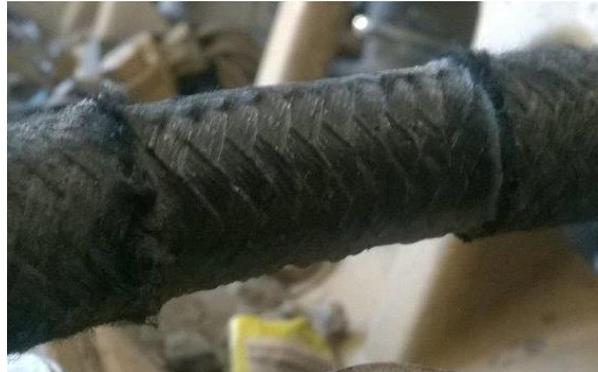
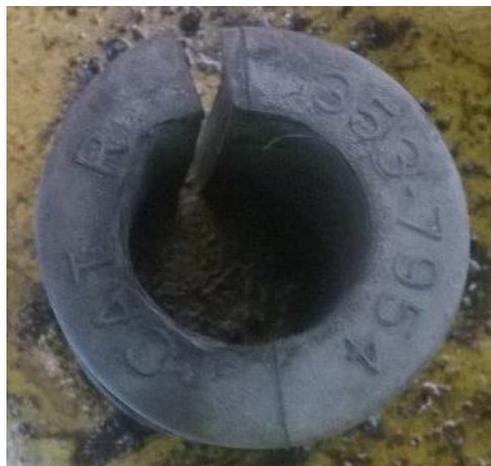
There have been several improvements made to extend the life of the engine flexible fuel lines since the introduction of the D10T and D11T. These include updated fittings, hoses, an additional mounting bracket, and improved rubber grommets that resist hardening when subjected to sustained high engine compartment temperatures. The introduction of these improved grommets, together with greater emphasis on field installation quality, 500-hour inspections<sup>2</sup> and recommended replacement of grommets and hoses at 6000 hours, has seen a significant decrease in the reporting of fuel line damage and fires. Abrasive wear may occur between the outer layer of the flexible fuel lines and the improved rubber grommets between 6500 to 7000 hours. Refer figure 3.

**Figure 3. These photos show wear to the corresponding surfaces of a hose and grommet that have been in service for 6500 hours. Accelerated wear occurs from the resulting clearance. In some instances, abrasive material can enter this clearance and further accelerate wear.**

**Correct any defects identified during this inspection procedure before operating the machine.**
