Bulletin 006/2012

Subject: Caterpillar AD55B Fuel Transfer Pump De-isolation after Service Work has been performed on Fuel System.

Affected Product: AD55B Underground Articulated Truck Serial Prefix: JNW

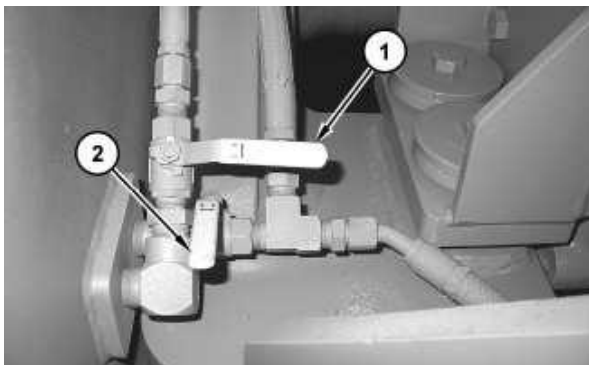
Left side of machine

1. Return valve - LHS 2. Supply valve - LHS 3. Supply valve-RHS

NB. All valves shown in closed position

Ensure all valves on the fuel system that are required to be open for engine operation are open after a service task is completed. Refer illustrations below.
