Bulletin 005/2013

Subject: Incorrectly Manufactured Hydraulic Hoses (80bar)
Affected Product: Cat6060/6060FS (RH340, RH340B)
Serial numbers: 340094 to 340125
Risks Identified: Defective hoses may result in serious injury or death.

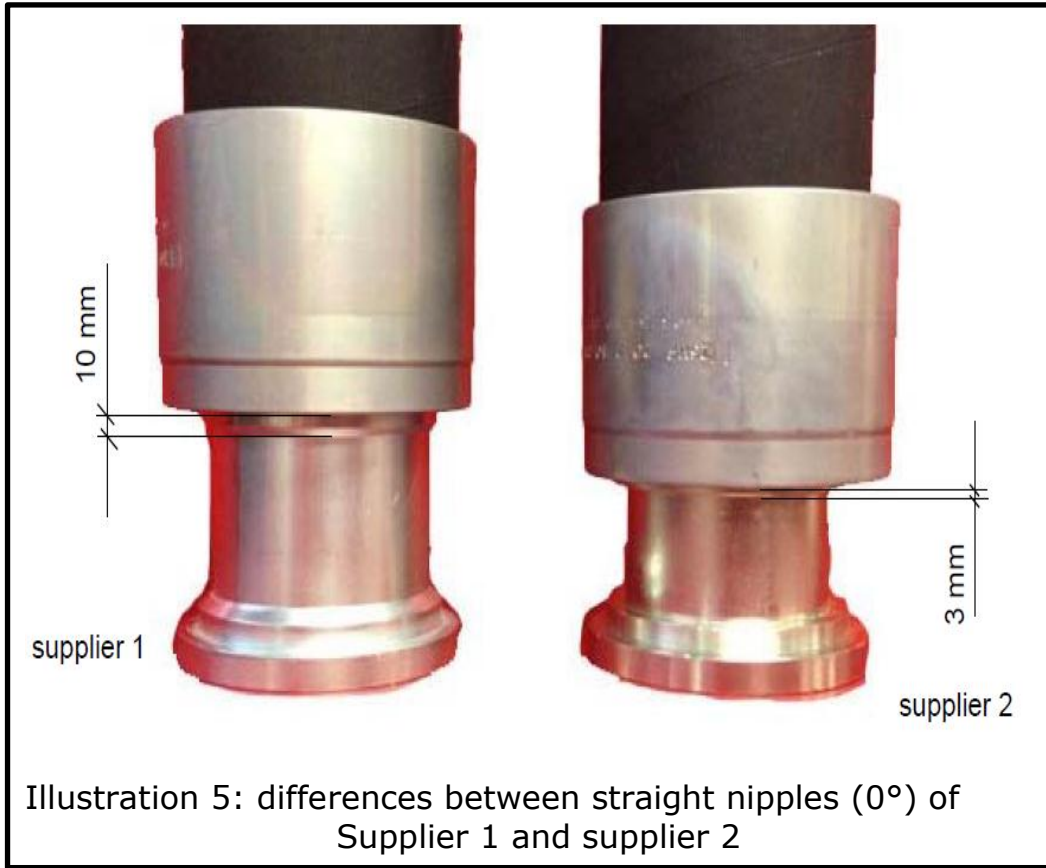
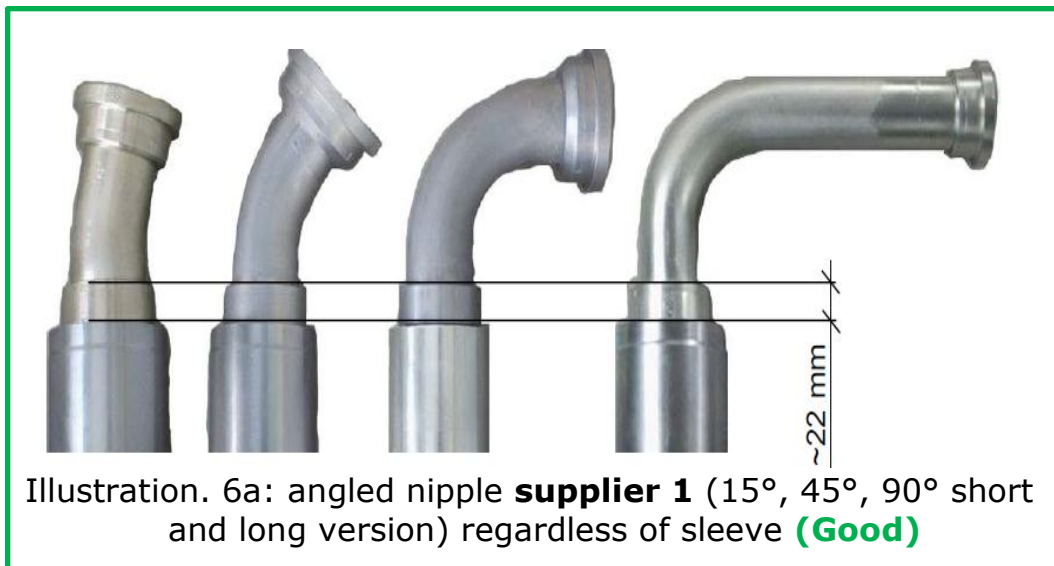
1. The part number and manufacturing date of the hose are stamped on the crimped sleeve - refer illustrations 1 & 2. The date stamped on the sleeve must fall in the range October 1 2010 to October 31 2011.
2. Affected hoses contain either a sleeve or nipple from supplier 2. Supplier 2 fittings can be identified by two rings on the sleeve circumference, as shown in illustrations 4 and 7 of this bulletin.

Illustration 4: **Supplier 2** sleeve always with two machined rings on circumference. (**Bad**)

1. Inspect machines in the affected serial number range. If the inspection shows defective hoses are fitted, replacement hoses must be ordered and fitted immediately.
2. Inspect parts stock holdings of affected part numbers shown in this bulletin. Defective hoses identified in this inspection must be replaced.
3. Destroy defective hoses by cutting the hose at the crimped fittings at each end to render the hose unusable and attach a picture of destroyed hose to the warranty claim.
